MODEL 124**with retrofitted anti-theft alarm system (DWA)****Shown on model 124 sedan**

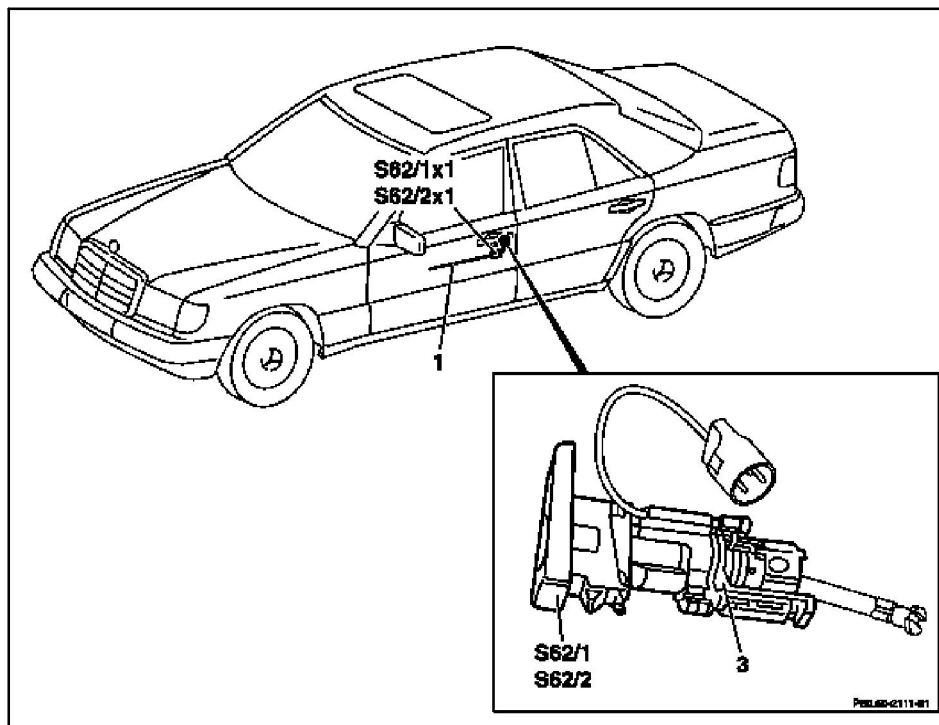
P80.50-2200-06

- 1 Connection cable
 3 Lock cylinder
 S62/1 Front left door switch, ATA
 S62/1x1 Plug connection of front left door switch, ATA
 S62/2 Front right door switch, ATA
 S62/2x1 Plug connection of front right door switch, ATA

i The previous lock pushbutton is no longer available. When carrying out repairs a new lock cylinder (guide) for the anti-theft alarm system must be installed.

1	Connect quiescent current retention device		*WH58.30-Z-1005-09A
2	Disconnect ground cable of battery		
3	Remove lock cylinder of front door	i Remove only lock cylinder with faulty lock pushbutton.	
4	Remove door trim panel on inside		
X	Installation		
5	Install lock switch		
6	Install wiring harness		SM80.50-P-0002-01A
7	Perform function check	i Refer to operating instructions of anti-theft alarm system.
